Forensic Architect's Investigation of Golf Course Safety

by *Michael S. Johnstone, AIA (NAFE 361C)*

Case No. One – Property damage due to errant golf balls

Case No. Two – Personal Injury due to errant golf ball

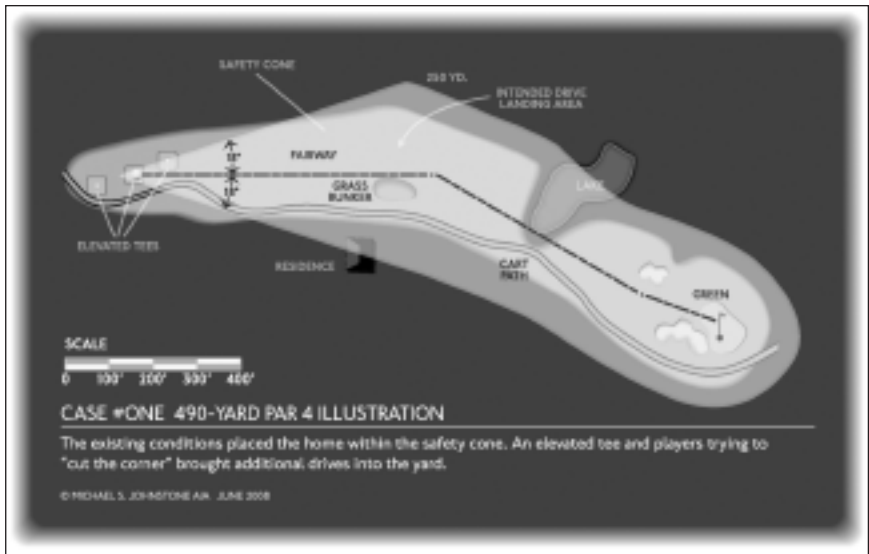
Figure #7.

The home owner retained an attorney and filed suit against the Country Club to cease and desist playing that hole. The author was retained directly by the home owner as a golf course design consultant. The author visited the site, documented the existing conditions and plotted the probable flight of a high percentage of tee shots. The house sat at ground zero for slicing flight of right handed players teeing off from an elevated tee. The author took the owners statement about his experiences, obtained scaled aerial photos, and reviewed photos of the damage. After a discussion with the original Golf Course Designer, he stated that he had heard about the problem at this home and mentioned that they had much less intrusion when the grove of substantial trees that he had placed in front of this home had been blown down during the storms Ivan and Francis!

As a result of the author's analysis the following changes were proposed and documented for the hole:

1. Re-orient the tee boxes to aim toward the intended landing area to the left side of the fairway.
2. Place a target pole in the center of the intended landing area.
3. Replace the trees that had been blown down in previous hurricanes.

4. Place a tall hedge to the right of each tee to channel drives to the left.
5. The owner should add a “natural grasses” garden at the rear of his property to create an area which makes the retrieval of out of bounds shots very difficult.

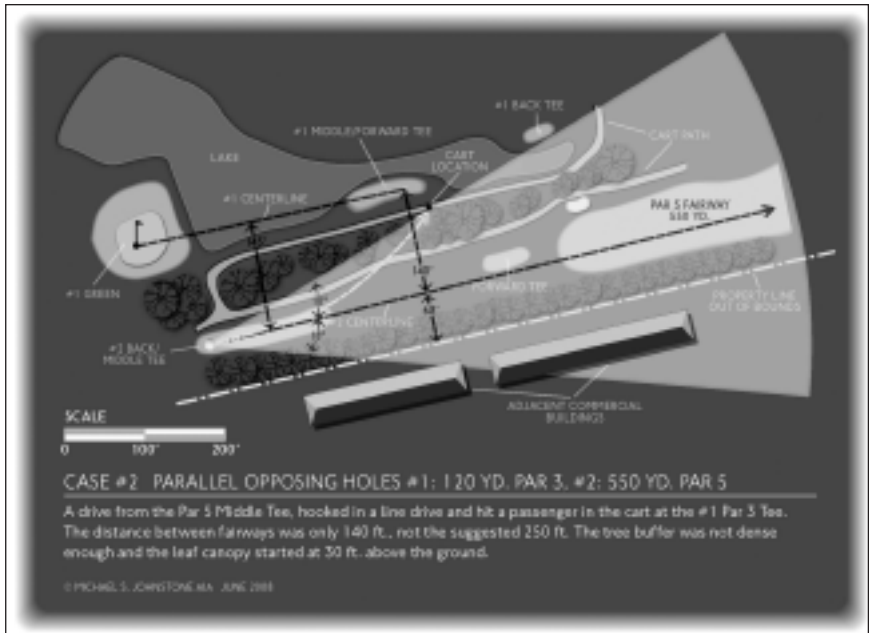
Figure #8.

The tee on the #1 Par 3, where the accident occurred, was located parallel to the #2 Par 5 that played in the opposing direction with the tee only 160 feet from the accident scene. The center line of the #1 Par 3 Fairway was only 140 feet from the #2 Par 5 center line and well within the Safety Envelope. Trees that formed a partial buffer between the two fairways were mature, widely spaced and the leaf canopy began at about 30 feet from the ground. There was no other protection, such as additional lower vegetation, shrubbery or safety screens and no warning signs at either tee.

In an attempt to provide a long Par 5 hole the Golf Course Designer shoe-horned the fairway along the exterior property line violating the Safety Envelope on both sides of the fairway and creating a hazardous condition for golfers on the #1 Par 3 Tee and the adjacent commercial properties.
