Forensic Architect's Investigation of Golf Course Safety

by *Michael S. Johnstone, AIA (NAFE 361C)*

Case No. One – Property damage due to errant golf balls

Case No. Two – Personal Injury due to errant golf ball

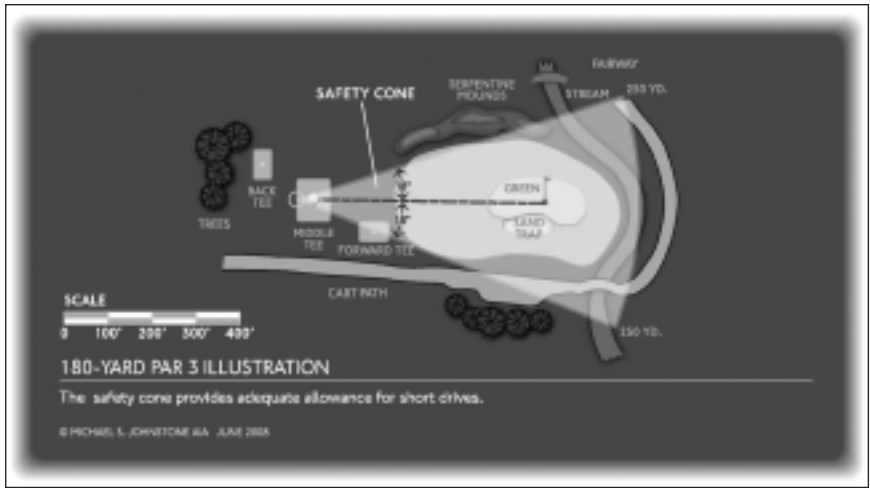
Figure 1

Figure #1 illustrates depicts the basic elements of a fictitious Par 3, 200 yard golf hole. Par being the standard number of strokes in which a player would be expected to complete the hole. There are at least three tees of varying distances to allow players of different abilities to choose the length they wish to play. The fairway is defined by how the turf is cut and outlined by trees, a deeper cut of grass, potential out of bounds stakes, sand traps and mounding. The green has an even shorter grass height (approximately 1/8”) and has a grass halo referred to as the fringe.

The Safety Cone is a pie shaped area generated by drawing a fairway centerline starting at the back of the middle tee (determined by the Golf Course Designer for each unique hole) and then creating two radiating lines at 18 degrees to the right and left of the centerline. The Safety Cone then extends out for a distance of 250 yards. Approximately 80% of drives can be expected to come to rest within the Safety Cone.

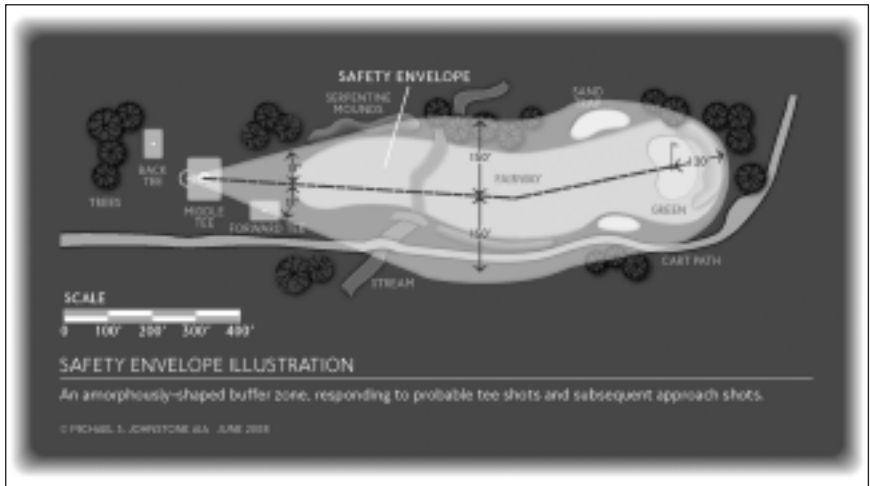
Figure 2

The Safety Envelope extends beyond the Safety Cone to define a space buffer around the entire fairway and green. The side limits of the envelope should be at least 150 feet from the centerline of the fairway. The limit behind the green should be at least 120 feet. Planting, trees, hazards, mounding and screening can also be employed to help contain errant golf shots.

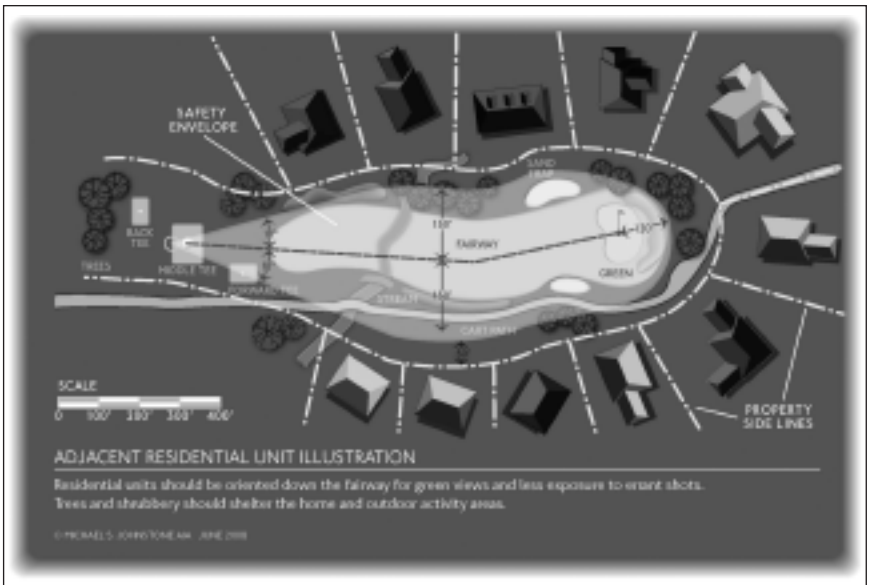
Figure 4

In residential golf communities, the adjacency of the golf course and residences and backyards creates the potential for personal injury and property damage. After applying the Safety Envelope test, the shared property should be set outside of the Safety Envelope and take into consideration the topography, vegetation, prevailing winds and fairway layout. At this point the Covenants, Conditions and Restrictions of the residential development should describe an additional setback for the home and amenities such as swimming pools and out buildings to further protect residential property and maintain the residence views. Homes should be oriented to face down the fairway to reduce the amount of glass exposed to incoming errant shots.

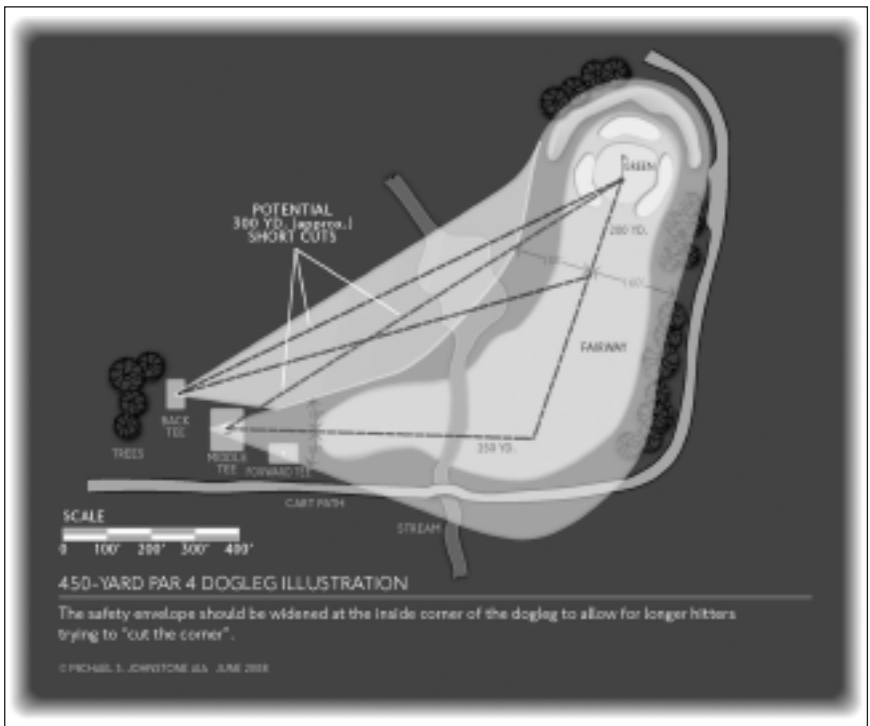
**Figure 5****Figure #5.**

A sharp "Dogleg" fairway creates an invitation to longer hitters to cut the corner of the Dogleg in order to shorten the hole. Residences, commercial structures and adjacent fairways should not be placed in the inside corner zone.
